1 Building constructions characteristics and mechanical properties of confined masonry walls
2 in San Miguel (Puno-Peru)

4 Tarque Nicola ^{(1)*}, Pancca-Calsin Erika ⁽²⁾

5 ¹ Pontificia Universidad Católica del Perú. GERDIS Research Group, Civil Engineering Division.

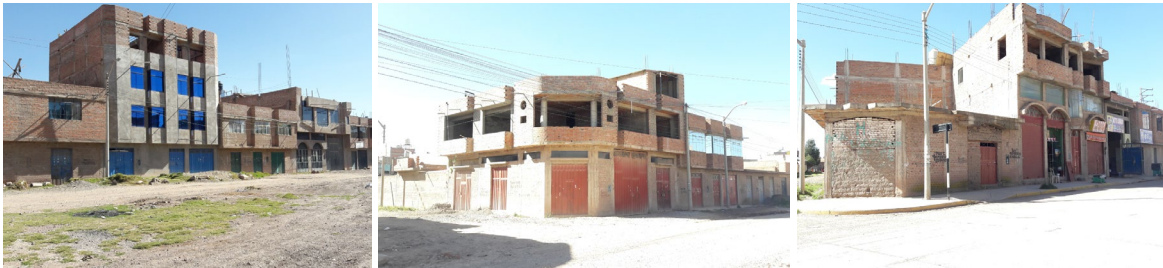
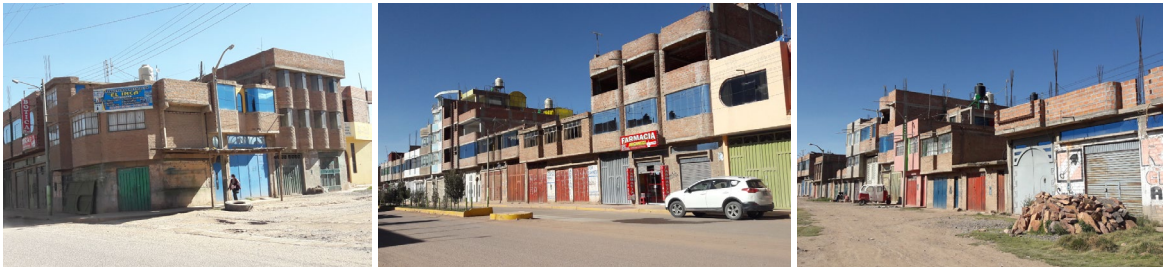
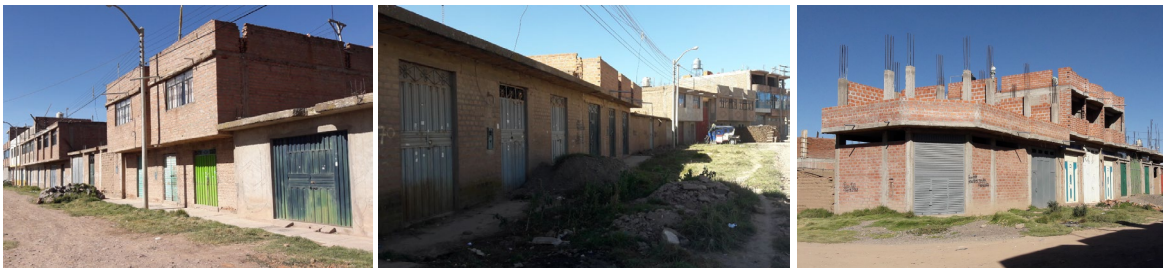
Figure 2. Some surveyed households in the district of San Miguel (Puno).

108 Unfortunately, it was impossible to have a more significant number of surveys because many
109 villagers were afraid that this study was part of the local government's tax data update campaign.
110 Nevertheless, figure 2 shows some of the surveyed dwellings, where it can be noticed how these
111 dwellings grow without an adequate architectural order.

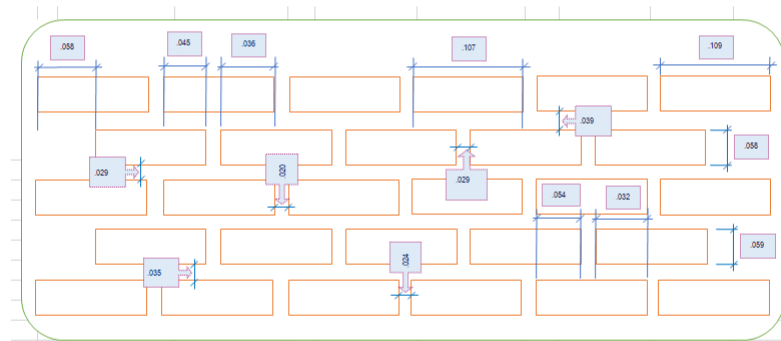
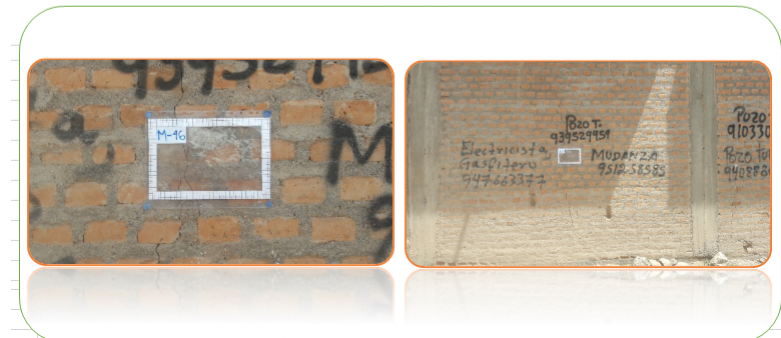
Figure 3. (Continuation) Household survey sheets, in Spanish.

Presenta grieta vertical a lo largo de la parte central del muro del tipo escalonada y mixta. Se aprecia también excesivas juntas de mortero y unidades de arcilla de baja calidad. Presenta una deficiente interacción columnas - muro, debido a que no existen los dentados de 5cm. El concreto en la columna surge desde el sobrecimiento.

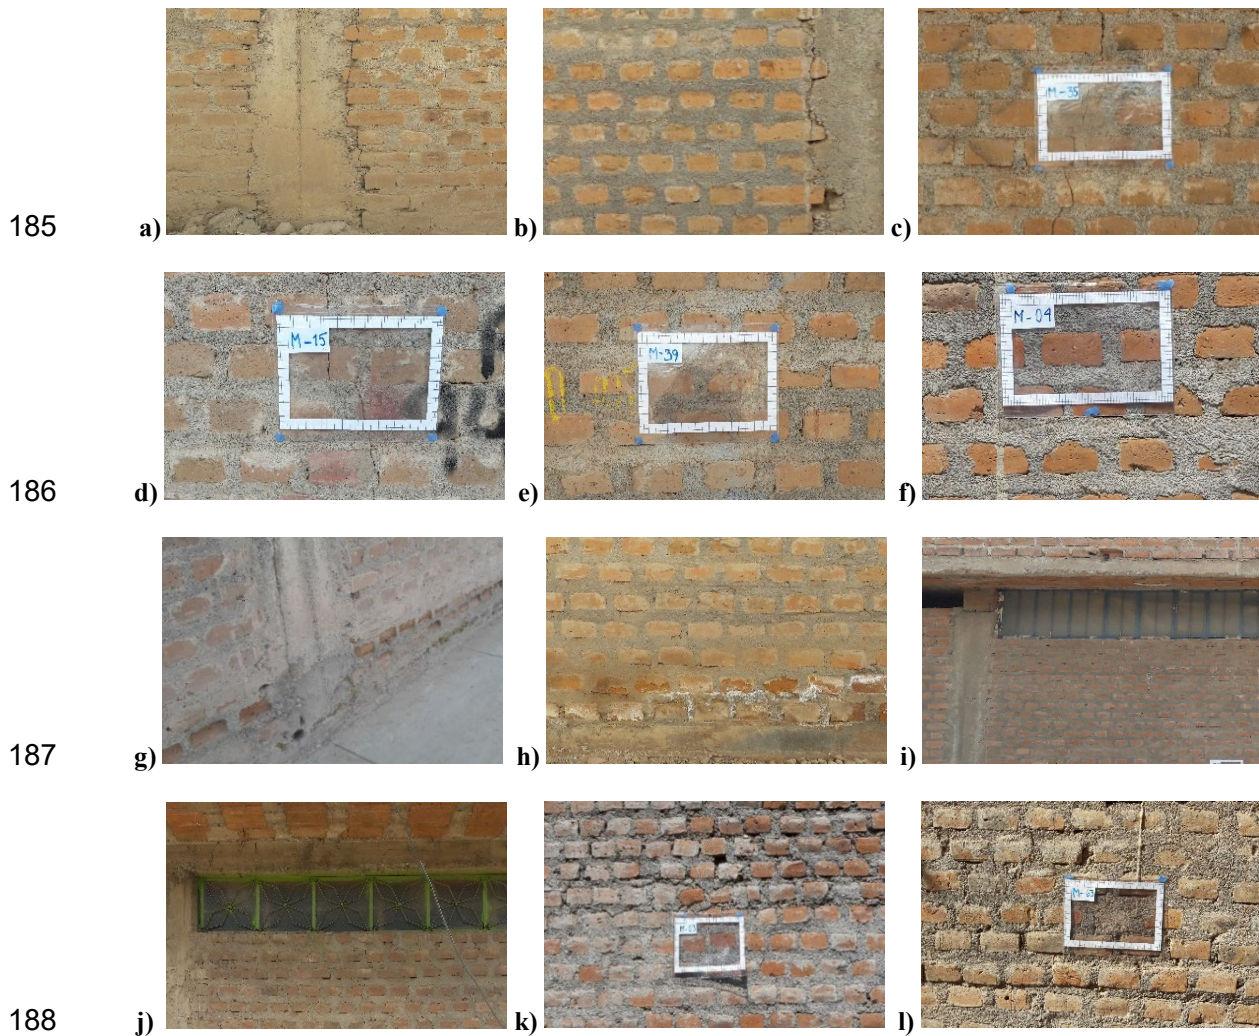
189 **Figure 6. Existing pathologies in analyzed dwellings.**

Vulnerability usually manifests itself through various pathologies that appear in buildings, ranging from minor damage and inconvenience to the occupants to significant failures that can cause the collapse of the dwelling or part of it (Astorga and Rivero 2009). Figure 6 shows the different pathologies found in the studied dwellings. For example, Figures 6a and 6b show an inadequate connection of the masonry units with the confining element since both elements have cracks or separations. In addition, figures 6c and 6d show that some houses have cracks in their walls. These cracks usually appear when there are differential settlements in the foundation due to low-strength concrete or the deficient use of reinforcing steel in the confining elements (Mosqueira and Tarque 2005). Likewise, Figures 6e and 6f show mortar joint thicknesses more significant than 15 mm (value recommended by NTE 070).

Moreover, these thicknesses are not homogeneous. Figures 6g and 6h show walls with efflorescence damage, a crystalline deposit (saltpetre) generally white colour that develops in the masonry or on the surface of the concrete, which, if not repaired, can increase and weaken the wall (Sathiparan and Rumeshkumar 2018, Annila et al. 2018). Figures 6i and 6j show no confining beam for the wall, and the columns are short due to the existence of windows. Finally, Figures 6k and 6l show the poor quality of the workmanship used in the construction of many houses, which, according to Mosqueira and Tarque (2005), can cause a reduction of up to 40% in the shear strength of the walls.

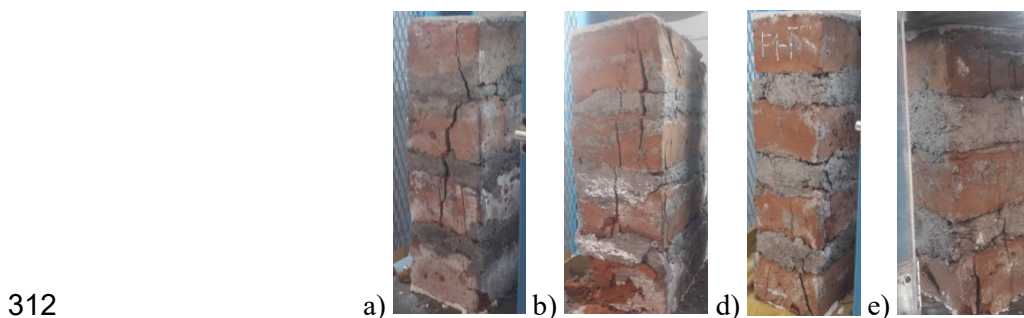
313 **Figure 9. Failure mode of the tested piles, a) TP, b) T1, c) T2, and d) T3.**

310 Figure 9 shows that failure in the piles was the development of vertical cracks through the units and
311 mortar.

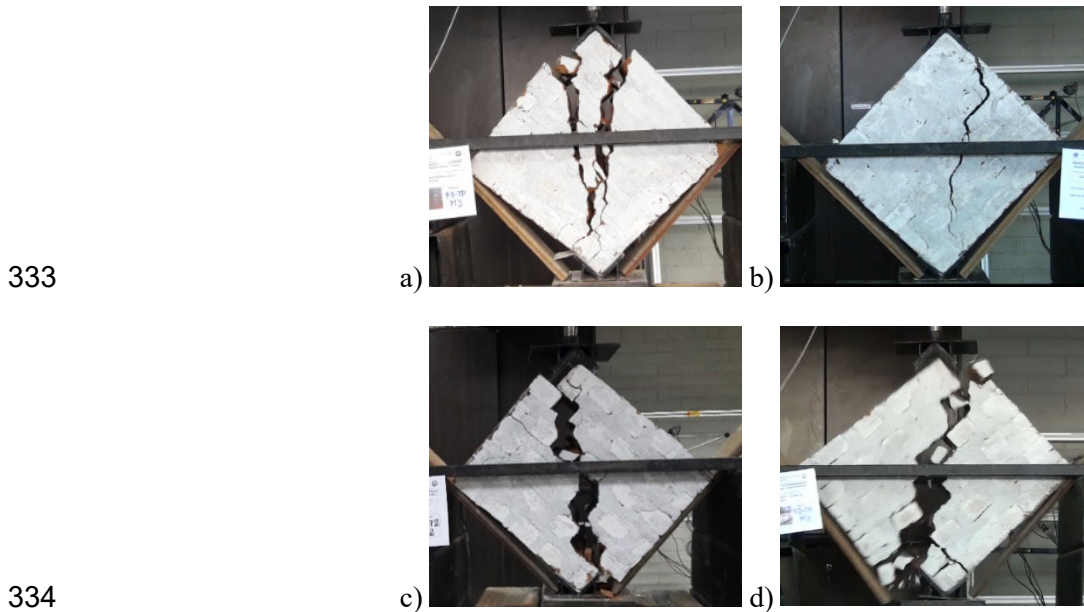
335 **Figure 11. Failure shape of the tested walls, a) TP, b) T1, c) T2, and d) T3.**

330 The wall failure mode was mostly by diagonal cracking and breaking bricks and mortar, as shown in
 331 Figure 11. The two wooden tables along two wall sides were placed to avoid the fall of the broken
 332 pieces, but they did not have interaction with the walls during the tests.
