# Multi-criteria Analysis of Five Reinforcement Options for Peruvian Confined Masonry Walls

**Abstract.** In Peru, construction of dwellings using confined masonry walls (CM) has a high percentage of acceptance within many sectors of the population. It is estimated that only in Lima, 80% of the constructions use CM and at least 70% of these are informal constructions. This mean that they are built without proper technical advice and generally have a high seismic vulnerability. One way to reduce this vulnerability is by reinforcing the walls. However, despite the existence of some reinforcement methods in the market, not all of them can be applied massively because there are other parameters to take into account, as economical, criteria for seismic improvement, reinforcement ratio, etc. Therefore, in this paper the feasibility of using five reinforcement techniques has been studied and compared. These reinforcements are: welded mesh (WM), glass fiber reinforced polymer (GFRP), carbon fiber reinforced polymer (CFRP), steel bar wire mesh (CSM), steel reinforced grout (SRG). The Multi-Criteria Decision Making (MCDM) method can be useful to evaluate the most optimal strengthening techn

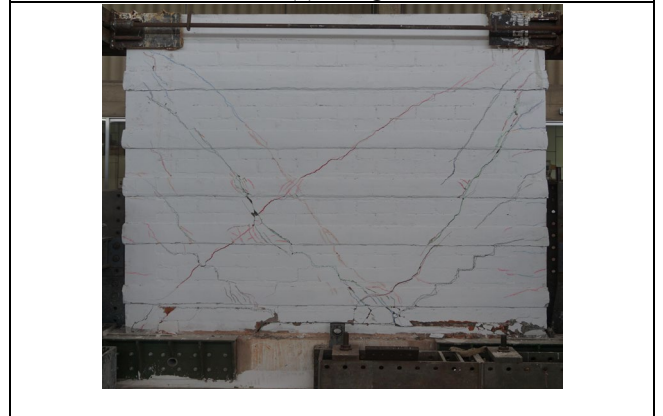
Fig. 17 Strengthening with SRG

(a) Original

(b) Strengthened

According to the evolution of cracks, although there were diagonal cracks, these were the result of the spreading of smaller cracks produced in previous phases, which is not typical of a failure by shear stress. Therefore, a failure of the wall by bending stress was predominant. Fig. 17 shows the failure pattern for both walls, original and strengthened.

The first cracks of the strengthened wall occurred at a 0.04% drift and were due to bending stress in the tie-columns. In phases 4 and 5 (drift = 0.08% and 0.12%, respectively) diagonal cracks started to appear on the masonry panel, at low and high heights, from the joint of the columns with the masonry towards the center of the wall. Some of them corresponded to the opening of repaired cracks of the original wall. At a 0.16% drift, no new cracks appeared, but the already existing ones intensified. At a 0.23% drift, two of the diagonal cracks intercepted on the lower part of the masonry panel, forming a V shape. Like the original wall, this is due to a generalized failure by bending stress in the strengthened wall. In phase 8, at a 0.32% drift, a new, not very long, diagonal crack appeared on the masonry panel from the upper corner towards the center of the wall. From phase 9 (drift = 0.45%), the opening of cracks started causing the surface detachment of the masonry. In phase 11, at a 0.83% drift, a new diagonal crack appeared in the opposite direction to the one mentioned in phase 8. This crack was indeed generated along one of the diagonals of the wall, so it is associated to a failure by shear stress. Finally, at a 1.25% drift, the diagonal cracks, generated in phases 8 and 11, intercepted forming an X shape.
