# Experimental assessment of confined masonry walls retrofitted with SRG under lateral cyclic loads

## Abstract

*Keywords:* confined masonry wall, seismic retrofit, SRG, seismic vulnerability

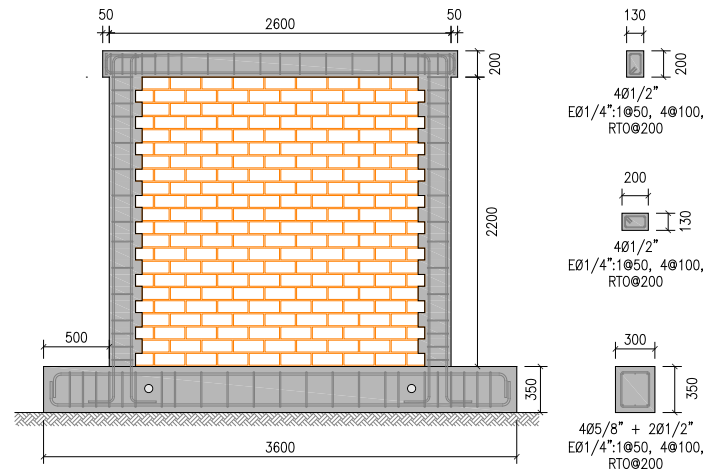
commonly used for bearing walls in Peru, although prohibited by the Peruvian Seismic  
 65 Code in the coastal area [18]. The construction process of a typical confined masonry  
 wall implies that steel reinforcing is located in its final position before constructing  
 the masonry panel. It is not recommended to lay the bricks more than 1.3 m high  
 per working day, in order to avoid crushing the mortar in the lower part of the panel.  
 The typical mortar thickness, either horizontal or vertical, varies between 10 and 15  
 70 mm and has a typical volumetric ratio cement/sand of 1/4. Moreover, an intentional  
 toothed finish is left for a subsequent concrete casting. In this way, it is intended to  
 guarantee a monolithic union between concrete and masonry. The dimensions of a  
 typical confined masonry wall as well as the reinforcing detail are shown in Fig. 1.

Figure 1: Geometry and reinforcement detail of a typical wall (dimensions in millimeters)

Regarding the detail of reinforcement of the confining frames, it should be taken  
 75 into account that in confined masonry construction, these elements are not designed to  
 act as moment-resisting frames. As a result, detailing of reinforcement is simple [19].  
 In fact, a common practice in Peruvian Constructions is to use corrugated steel rods of  
 $\phi 1/2''$  as longitudinal reinforcement and  $\phi 1/4''$  as transverse stirrups. Fig. 1 shows the  
 dimensions and reinforcing detail for a typical tested wall.

195 From the geometry of a typical tested wall (Fig. 1), it was possible to deduce  
 $d = 2500$  mm. Regarding SRG's properties, it was assumed that once the SRG is  
 cracked, the tensile behaviour of the composite is governed by the steel textile. For this  
 reason,  $E_f$  was taken to be the Young's modulus of the steel mesh:  $E_f = 150$  GPa (Ta-  
 ble 3). Due to the fact that  $\epsilon_{fu}$  was greater than 0.004 in all tests (Table 3),  $\epsilon_{fv} = 0.004$   
 200 was adopted. Regarding  $A_{fv}$ , it was assumed that the strips were 100 mm wide and that  
 there were 16 steel cords, which resulted in  $A_{fv} = 8.6$  mm<sup>2</sup> according to the manufac-  
 turer's data sheet [23]. Finally, 450 mm was assumed as the separation between strips  
 for design purposes. Fig. 4 shows the reinforcing scheme adopted for the present work.

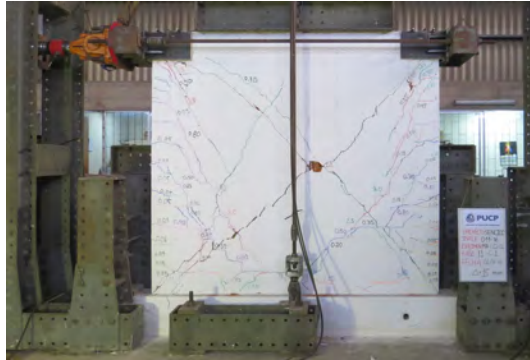
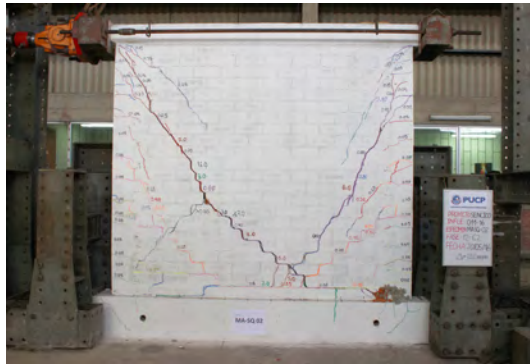
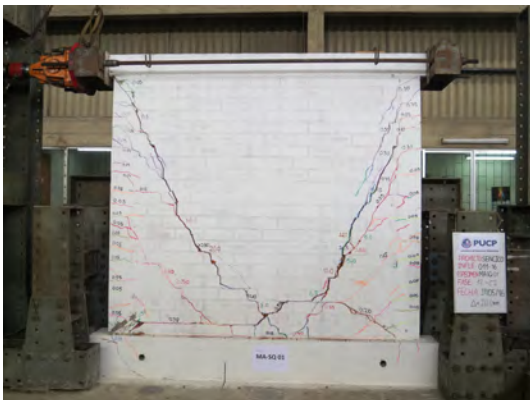
(a) With vertical load W-01

(b) without vertical load W-02

(c) without vertical load W-03

Figure 2: Selected walls for retrofitting

Regarding the tests conducted by [16, 17], three walls were tested under only lateral loads, until a repairable limit state was reached, i.e. equivalent to a drift of 0.125% according to the Peruvian Code [18]. The next three, unlike the previous ones, were  
90 tested until a collapsed state was reached, which had a drift of 0.833%. Finally, the last three had a constant vertical load of 170 kN, which represents the vertical load on a first floor wall from a total of three, and were tested also until reaching a collapsed state, with an associated drift of 0.625%. In this research, a total of three cracked walls were selected from the previous research to be repaired and tested under lateral cyclic loads  
95 again. Within this selection, two walls were selected from the group of walls which were led up to a collapse state (drift = 0.833%), whereas the last one was selected from the group of walls which were tested with a vertical load. It should pointed out that the walls were randomly selected for representing any cracked wall which could be located at the first floor of a masonry building.

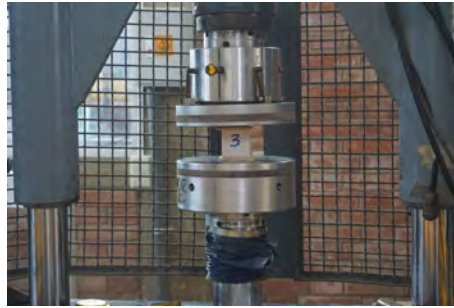
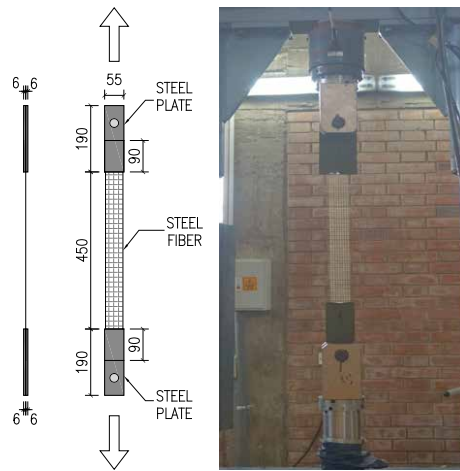
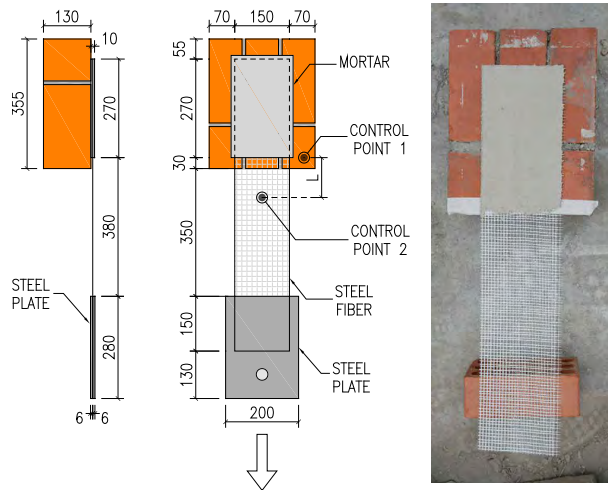
(a) Compressive test

(b) Tensile test

(c) Debonding test

Figure 3: Testing setup for control specimens (dimensions in millimeters)

135 In order to characterize the material properties involved in SRG, control tests were carried out. For instance, to characterize the natural lime mortar which serve as a binder for the steel galvanized fiber, 6 samples of 50 x 50 x 50 mm were made and tested after 28 days of curing, under uni-axial compression (Fig. 3a). Table 2 shows the experimental results from these tests, where the length and width resulted from  
140 averaging parallel dimensions from the face subjected to an axial load.

In the case of the galvanized steel fiber, 5 samples comprised of steel textile and steel plates which were joined by an epoxy resin, were made and tested, once the epoxy resin was totally dry (after 1 day), under uni-axial tension (Fig. 3b). In these tests, two main failure modes were recognized: one was related to the failure at the  
145 union between the textile and steel plates (U), whereas the other one was related to the middle part of the textile (M). It is worth noting that in these tests, the second failure mode is expected, in order to obtain a representative strength of the textile, since the first mode is linked to the participation of the steel plates in the failure. Table 3 shows the experimental results related to these tests, where  $E_f$  is the Young's modulus,  $f_f$  is  
150 the maximum strength, and  $\epsilon_{fu}$  is the maximum strain of the steel mesh.

Finally, the interaction between SRG and masonry substrate under shear loads was explored through 5 debonding tests, as shown in Fig. 3c, which were carried out after 28 days of curing. In these tests, 5 main failure modes were recognized: (1) rupture of the masonry substrate (2) debonding at the mortar-to-substrate interface, (3) debonding  
155 at the textile-to-mortar interface, (4) premature cracking of the outer mortar layer, and (5) rupture of the textile. Table 4 shows the experimental results related to these tests, where  $f_b$  is the maximum tensile stress developed by the steel mesh,  $\tau$  is the stress computed as the relation between the maximum force and the cross sectional area of the SRG, and  $Slip$  is the relative displacement of the SRG prior to total failure. For  
160 computing the  $Slip$ , two control points were located and connected by means of an LVDT into the specimens as is shown in Fig. 3. This LVDT measured a relative

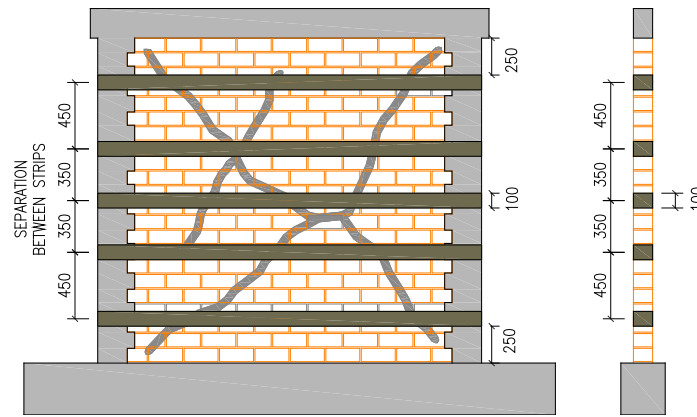
Figure 4: Details of the reinforcement for the repaired walls (dimensions in millimeters)

It should be noted that in Fig. 4, less separation between the strips was assumed  
 205 at the mid-height of the walls. This assumption was related to the fact that the largest  
 number of cracks were concentrated in the mid-height of the walls.

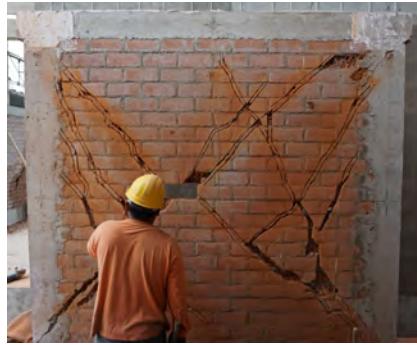
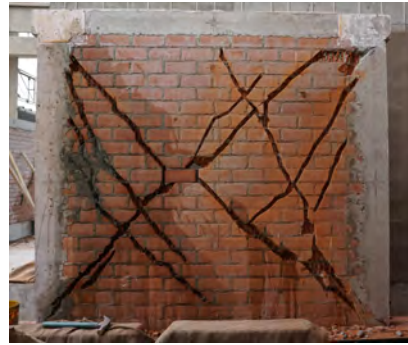
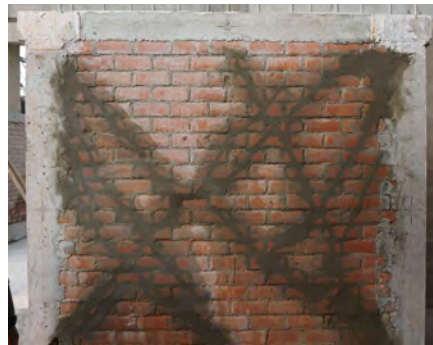
(a) Cracks opening

(b) Filling of openings

(c) Curing process

Figure 5: Main steps for repairing CMW (W-01)

Before retrofitting, it is necessary to make a proper repair of the cracks since a good  
 repair improves the recovery of the initial stiffness. In this study, cracks greater than 8  
 210 mm were opened using hand tools in order to avoid excessive out-of-plane effects. In  
 the case of crushed bricks, it is recommended to replace them by new ones (Fig. 5b).  
 Thereafter, the openings were filled with reparation mortar based on Portland cement  
 with a volumetric ratio cement/sand = 1/3. After being repaired, the walls should be

properly cured for at least 28 days. However, taking into account what would be done  
215 in a massive application, they were moistened three times a day for seven days. In this  
way, it was hoped to guarantee a reasonable resistance of the reparation mortar. Fig. 5  
shows the main steps involved in repairing CMW.

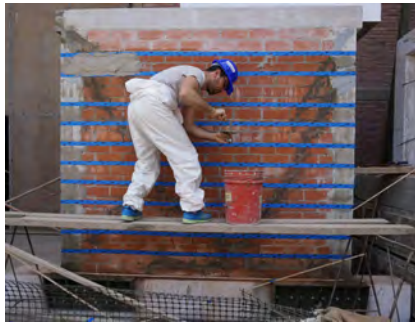
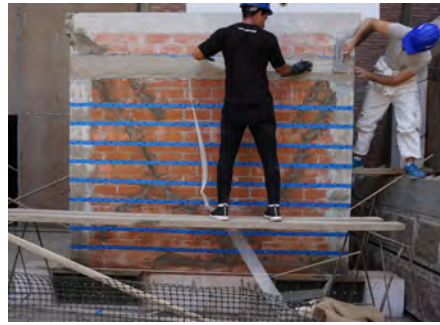
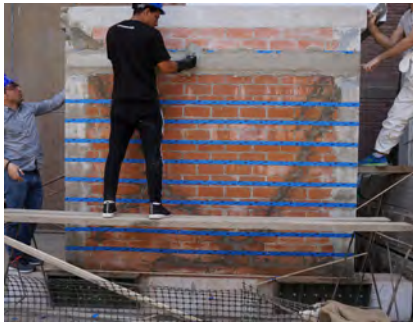
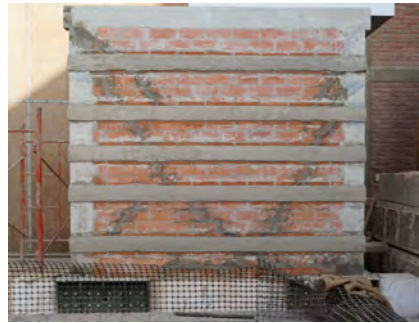
(a) First layer of mortar

(b) Placement of steel fiber mesh

(c) Second layer of mortar

(d) Retrofitted wall

Figure 6: Stages for strengthening CMW with SRG (W-02)

225 The retrofitting process started by moistening the intervention zone in order to avoid  
the absorption of the SRG's water by the masonry. Then, a first layer of mortar, 5  
mm thick, was laid upon the masonry within the area delimited by the Scotch tape.  
Subsequently, the steel mesh was embedded lightly inside the first layer of mortar.  
Thereafter, a second layer of mortar 5 mm thick was laid in order to finish covering the  
230 embedded steel mesh. Finally, once all the SRG strips were finished, the Scotch tape  
was removed to start the curing process. Fig. 6 shows the main stages of the retrofitting  
process as explained above. It is worth noting that, in this work, it was possible to  
anchor the steel mesh by overlapping them 250 mm interspersed at each column's  
ending, because it only had to reinforce isolated walls. However, for other applications,  
235 a proper anchor for the steel mesh must be previously studied or applied according to

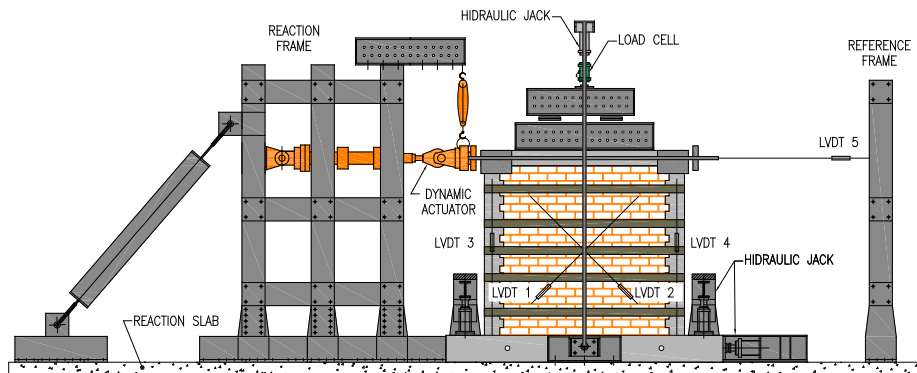
Figure 7: Setup and instrumentation for cycling test

Before testing, each foundation end was fixed to a reaction slab by means of hy-  
draulic jacks to restrict them vertically. Another hydraulic jack and a reaction frame  
were used as rigid horizontal stops also for the foundation ends. A vertical load of  
245 170 kN was applied by another hydraulic jack through two rigid steel beams in order  
to distribute the vertical load along the confinement beam. Regarding the horizontal  
cyclic loads, they were applied at the top of the wall by means of a dynamic actuator  
which was controlled by a computer.

Regarding the instrumentation, linear variable differential transformers (LVDTs)  
250 were placed, as shown in Fig. 7. Two LVDTs (LVDT 1 and 2) were placed along  
the diagonals of the masonry panel to measure their deformations and thus to have  
enough data in case an idealized strut-and-tie model is carried out. Another two LVDTs  
(LVDT 3 and 4) were placed at the confinement columns to measure their deformations  
due to vertical loads and bending effects during the cyclic test. One LVDT (LVDT 5)

255 was placed between the geometric centre of the confining beam and a reaction frame, which was assumed to be static. Fig. 7 shows the general testing setup as well as the instrumentation scheme for each cyclic test.

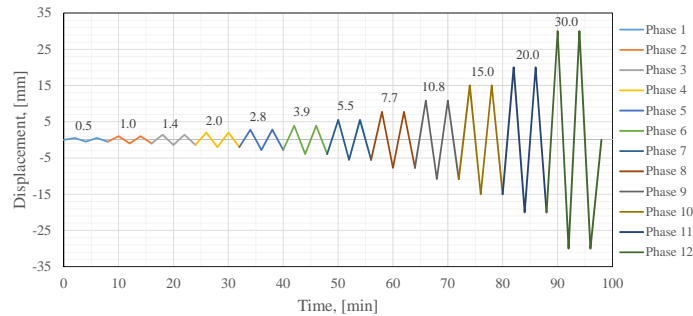
Figure 8: History of displacements

The cyclic loading was controlled by displacements, which means that the dynamic actuators applied displacements instead of forces. However, this had an internal load cell that allowed registering the load related to each displacement, thus it was possible to plot the corresponding hysteretic behaviour. In order to avoid kinematic effects, a quasi-static test was intended to be carried out by applying an average velocity of 0.25 cycles/minute. Regarding the applied history of displacements, it was defined according to FEMA 461 [26]. Thereby, each level of displacement resulted from increasing the previous level of displacement by a factor of 1.4. In addition, two cycles were also defined for each displacement level. It is worth highlighting that in the previous work [16, 17], only 11 displacement phases were considered, with a maximum displacement level of 20 mm, whereas in this work, 12 displacement phases have been taken into account, with a maximum displacement level of 30 mm, as shown in Fig. 8.

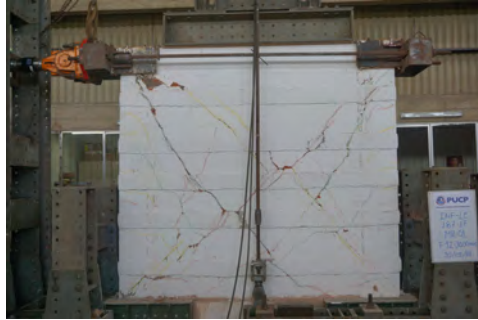
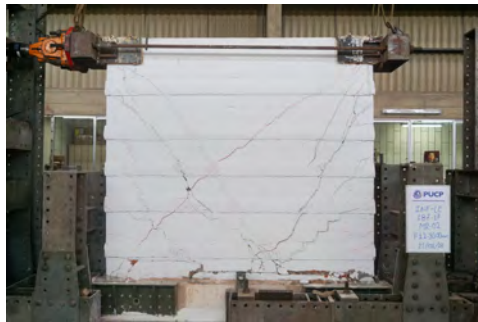
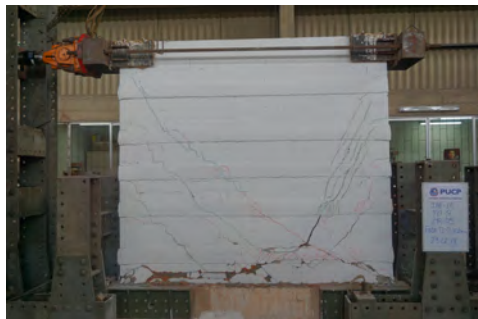
Figure 9: Cracking pattern of tested walls

In general, all the retrofitted walls showed bending cracks at the columns' feet prior to a drift of 0.12%, which corresponds to the fifth loading phase. Subsequently, the cracks that were previously repaired started opening. However, it should be noted that 285 not only the repaired cracks were opened during the tests, on the contrary, additional cracks took place. This effect can be noted in Table 6 by comparing the cracking pattern of retrofitted walls with those un-retrofitted. In addition, it is worth also noting that the tested walls suffered a mixed failure mode, namely, they started having cracks due to bending effects but finished having cracks also due to shear effects.

During the fifth loading phase (drift = 0.12%), the first visible cracks occurred at the  
300 columns' feet because of bending effects. Thereafter, progressive bending cracks began to appear along the column's height. These cracks were produced by the controlled elongation of the confining columns, given by the bond-slip effect present in the RC frames, during each loading phase [28]. It should be taken into account that whereas the steel reinforcement is able to carry tensile stresses, the concrete and masonry are  
305 able to carry compressive stresses and the wall is still stable, the confining frames will provide lateral displacement ductility to the wall. By comparing the reinforced wall with the original one, even when the cracks in the columns were not repaired, it could be observed that no extra cracks were significantly produced in these elements (Table 6). This is related to the fact that during the test, the confining elements acted as

Regarding the masonry panel, the first diagonal crack produced by shear effects took place at the seventh loading phase (drift = 0.23%). It should be noted that as the displacements increased, additional cracks due to shear effects occurred. Instead of  
315 RW-02 and 03, in this wall it was possible to observe the rupture of two SRG strips at the mid-height of the wall, which demonstrated that all the strength of the SRG could be developed. Nevertheless, it is worth mentioning that the ruptures were characterized by the breakage of the steel meshes and not by debonding failure, which demonstrated a perfect adhesion among the SRG's mortar and masonry substrate. Similarly, other

Like RW-01, the first visible cracks in these walls occurred at the columns' feet due  
to bending effects. However, unlike RW-01, they took place at the fourth loading phase  
325 (drift = 0.083%). With respect to the cracking of the confining columns, like RW-  
01, as the displacements increased, the number of cracks in height increased as well.  
Furthermore, it could also be noted that no extra cracks were significantly produced in  
the confining columns (Table 6).

Regarding the masonry panel, the first diagonal crack produced by shear effects  
330 took place at the eleventh (drift = 0.833%) and ninth (drift = 0.45%) loading phase,  
respectively. In addition, it should be noted that as the displacements increased, addi-  
tional cracks due to shear effects took place. Unfortunately, in these walls it was not  
possible to develop the total tensile strength of the SRG strips. Nevertheless, it should  
be highlighted that this means they were prepared to withstand more tensile stress than  
335 they were subjected to. In addition, it is worth noting that a horizontal crack took place  
in both cases at the base of the wall, to have a sort of rocking effect, as is shown by the  
shape of the hysteresis loops in Fig. 10. The results associated to the first cracking and  
maximum load capacity are summarized in Table 5.

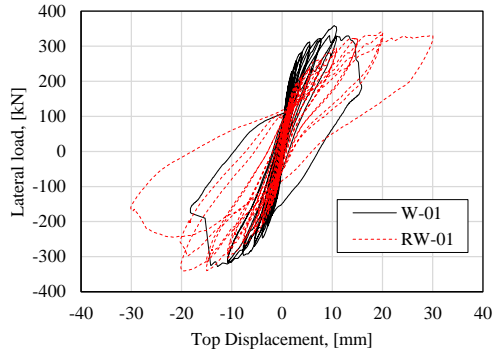
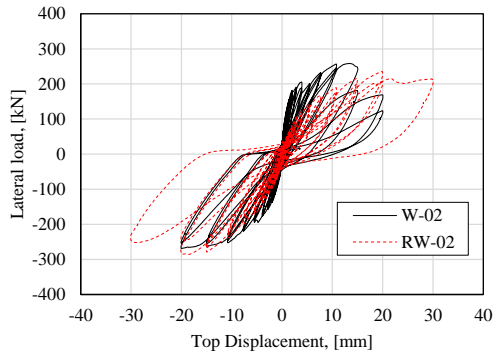
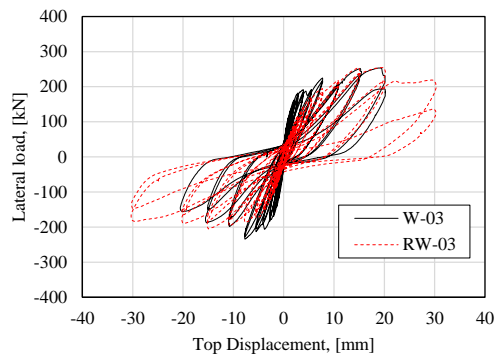
Figure 10: Hysteresis curves of tested walls

this occurred only in the pulling branch of the hysteresis loop (Fig. 10a).

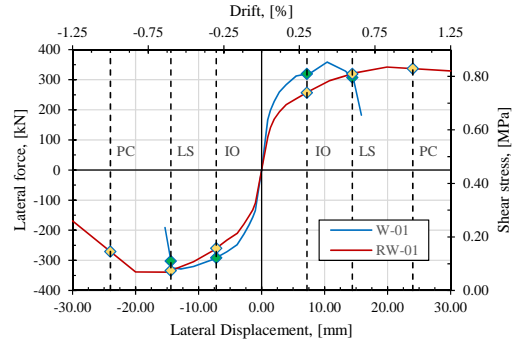
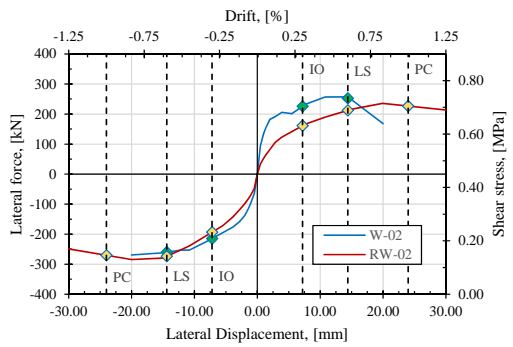
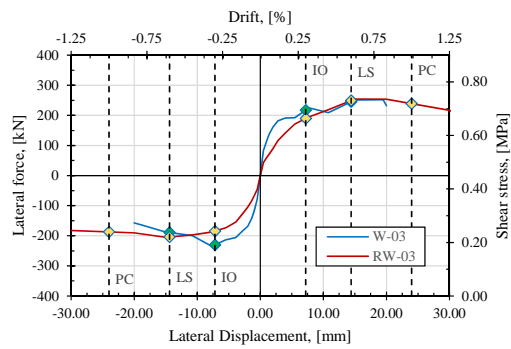
Figure 11: Envelope curves of tested walls

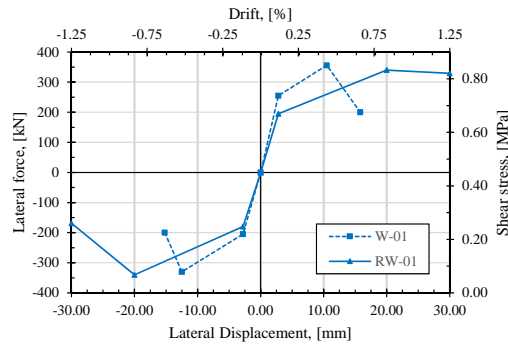
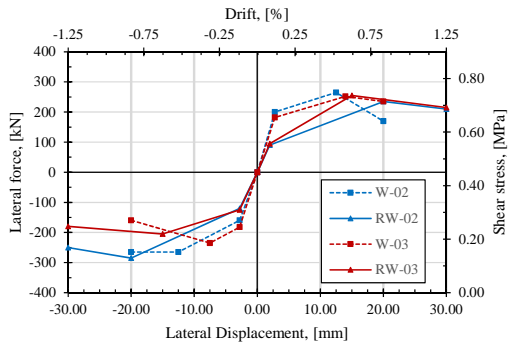
Figure 12: Backbone curves of tested walls

As mentioned above, the original walls were not able to reach the performance level of collapse prevention, which means they did not have enough ductility to resist lateral forces while maintaining their stability. Taking into account the final lateral displacement reached by each wall,  $\delta_u$ , and the displacement related to the first cracking of the masonry panel,  $\delta_y$ , the ductility was evaluated according to Eq. 5. In order to evaluate  $\delta_y$ , backbone curves were traced from the envelope curves shown in Fig. 11, by following the recommendations of [29]. These backbone curves were drawn by highlighting three main point: (1) first cracking, (2) maximum strength, and (3) ultimate state, as is shown in Fig. 12.

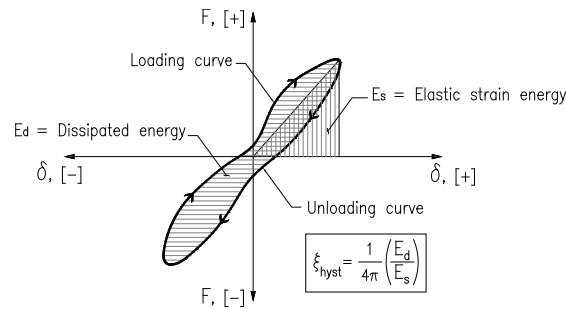
Figure 13: Calculation of energy dissipation and damping ratio

certain amount of energy absorption and dissipation is involved. In this section, the energy dissipation,  $E_d$ , will be evaluated by the area within each hysteretic loop, as shown in Fig. 13. Additionally, the equivalent hysteretic viscous damping,  $\xi_{hyst}$ , is evaluated as the ratio between the dissipated energy and the elastic strain energy, as shown in Fig. 13.

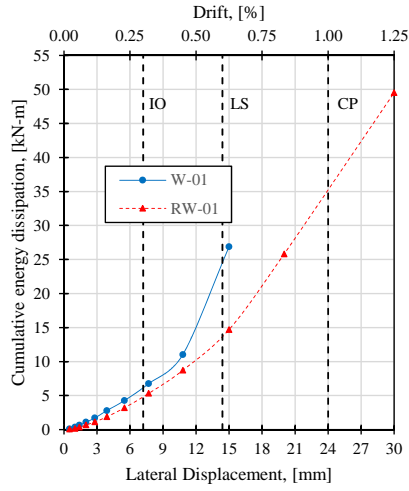
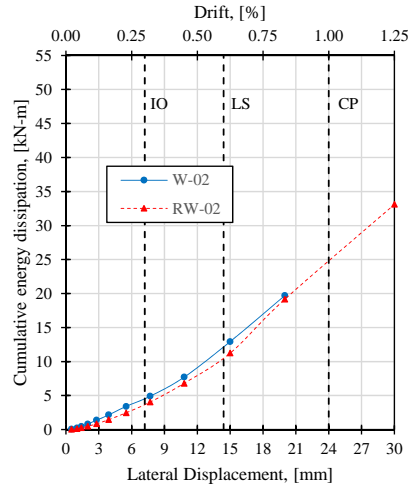
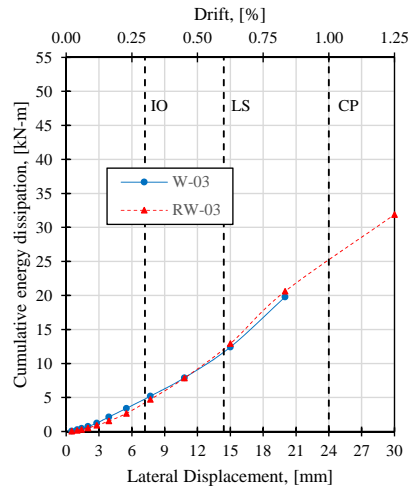
Figure 14: Cumulative energy dissipation for tested walls

Fig. 14 shows the cumulative energy dissipated for each loading phase. It has to be noted that the SRG gave the original walls the ability to dissipate more energy by means of greater inelastic displacements. In general terms, both the original and retrofitted walls had almost the same cumulative energy dissipation until the maximum displacement of the original walls. However, a freak tendency could be observed in the last loading phase of W-01, where an abrupt increment of energy dissipated was captured, as is shown in Fig. 14. This is related to the fact that in this loading phase an abrupt loss of capacity load (Fig. 10a) was registered, which in turn resulted in a quite large hysteretic loop. A similar phenomenon was registered for RW-01. However, this took place for a displacement that corresponded to the double of its original wall and

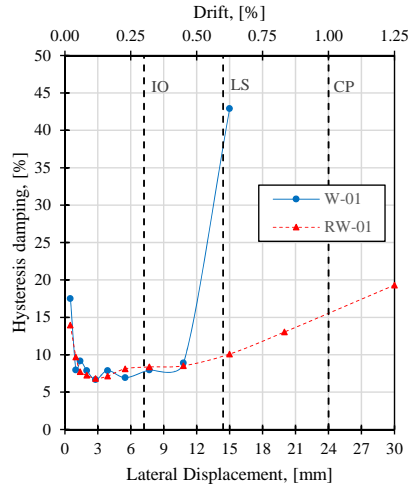
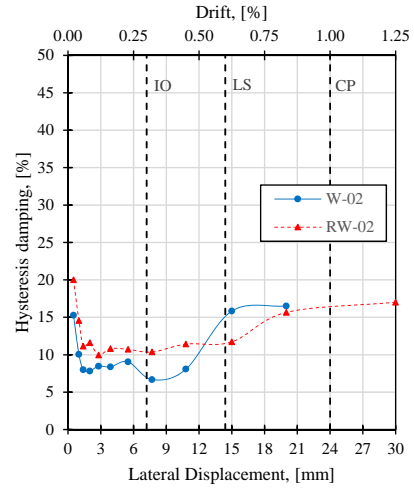
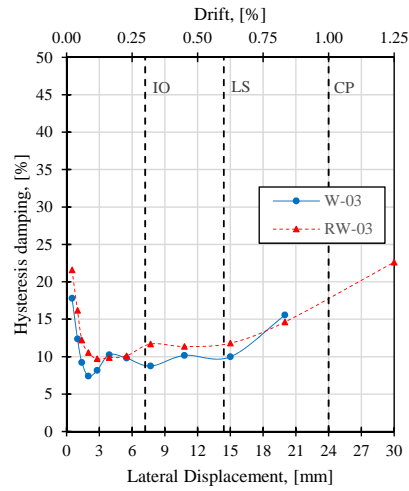
Figure 15: Hysteretic damping ratio for tested walls

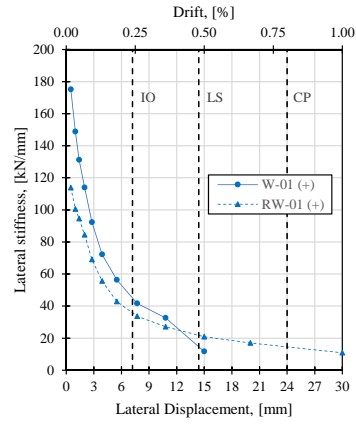
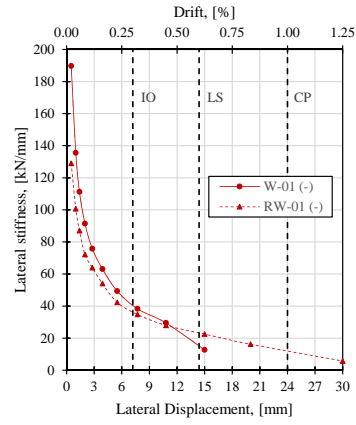
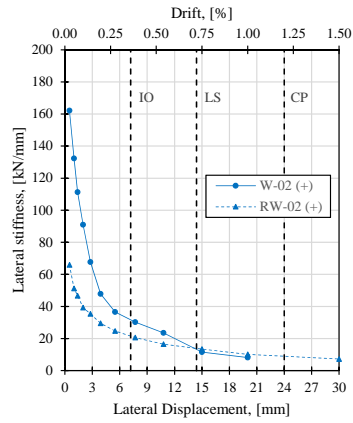
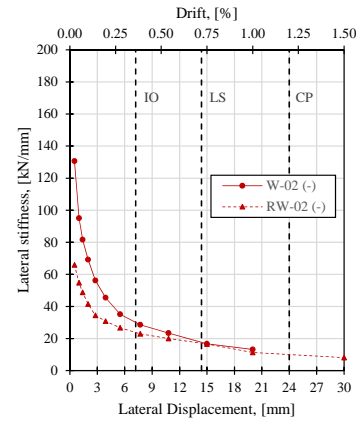
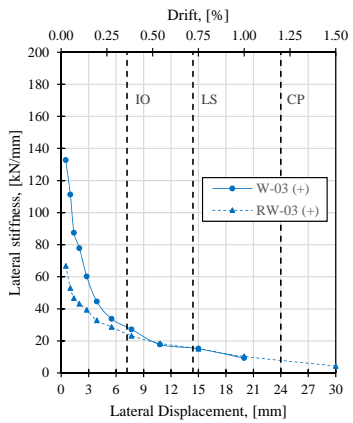
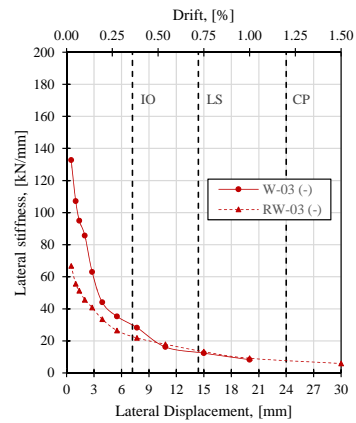
Figure 16: Stiffness degradation for tested walls

Fig. 16 shows the stiffness degradation of the tested walls. The same effect of the first two hysteresis loops is shown when computing the initial stiffness. Therefore, the initial stiffness was considered as that related to the third loop. It is important to highlight that the recovery of the initial stiffness will be as good as the goodness of the repair. On the other hand, since one aim of this work is to show that repairing and retrofitting with SRG can be done in an easy and massive way, this work tried to reproduce an effective and economic repair job, as explained above. This resulted in a recovery of 75% of the original wall's initial stiffness for RW-01 and 50% for RW-02 and 03.

The vertical load applied to W/RW-01 gives them more stiffness which is clearly evidenced in the first loading phases. However, at the same time, this makes them more brittle, which means they lose stiffness more quickly than W/RW-02 and 03, as new cracks take place or existing cracks become enlarged. Moreover, taking into account the fact that before the retrofitting, the walls were totally failed, one can be sure that the SRG had an impact on reducing the brittle behaviour of confined masonry walls. Indeed, Fig. 16 shows that regardless of the walls, the retrofitted ones showed a lesser stiffness degradation than the original walls, which in turn was related to the stability of the walls.
