Rope mesh as a seismic reinforcement for two-storey adobe buildings

Tarque Nicola^{1*}, Blondet Marcial¹, Vargas-Neumann Julio¹ and Yallico-Luque Ramiro¹

¹ GERDIS Research Group, Civil Engineering Division, Pontificia Universidad Católica del Perú, Av. Universitaria 1801, Lima, Peru

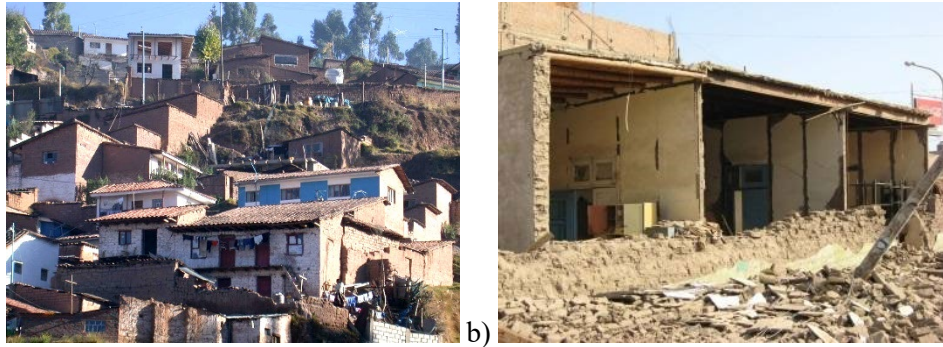
67 a) b)
 68 Figure 1. (a) Contemporary adobe houses in Cusco, Peru; (b) Out-of-plane failure of adobe walls during
 69 the Pisco (Peru) earthquake of 2007.
 70

65 unbalanced them, causing the roof to collapse as well. On the other hand, the roof would not have collapsed
66 if the walls perpendicular to the façade had supported the joists (Figure 1b).

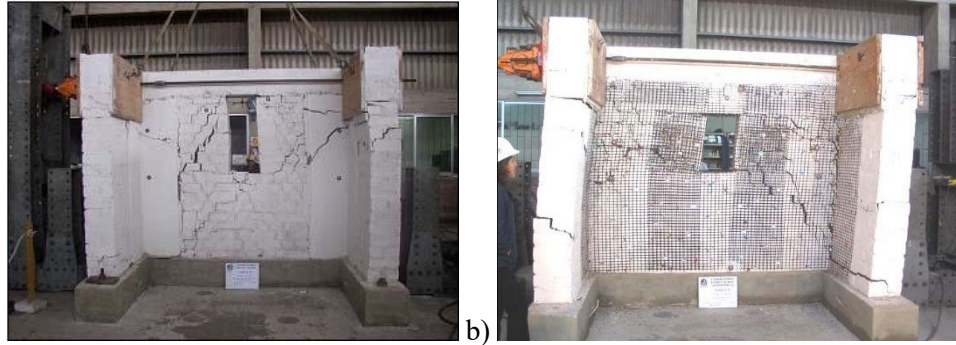
120 a) b)
121 Figure 3. Cyclin in-plane tests on adobe walls strengthened with: a) welded wire mesh and b)
122 geosynthetic mesh (Blondet et al. 2005)
123

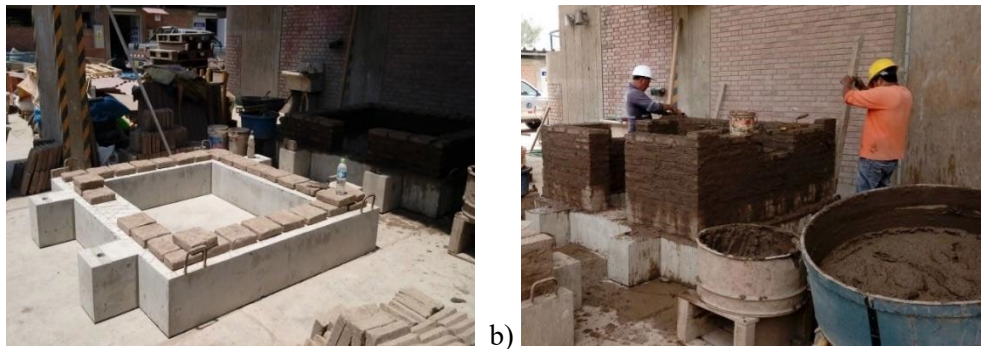
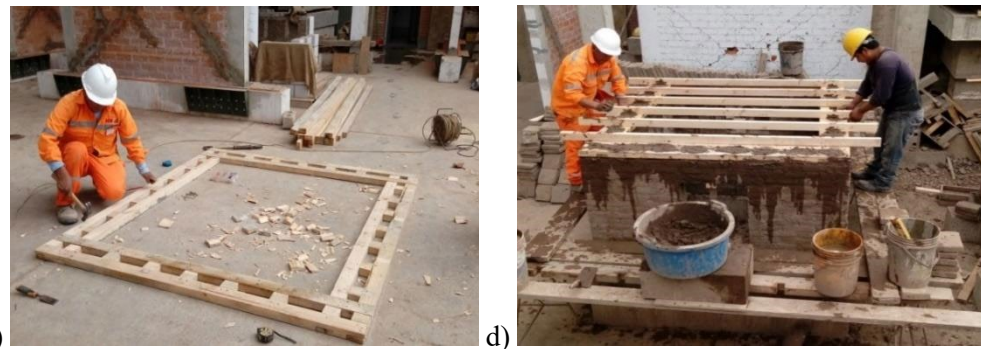
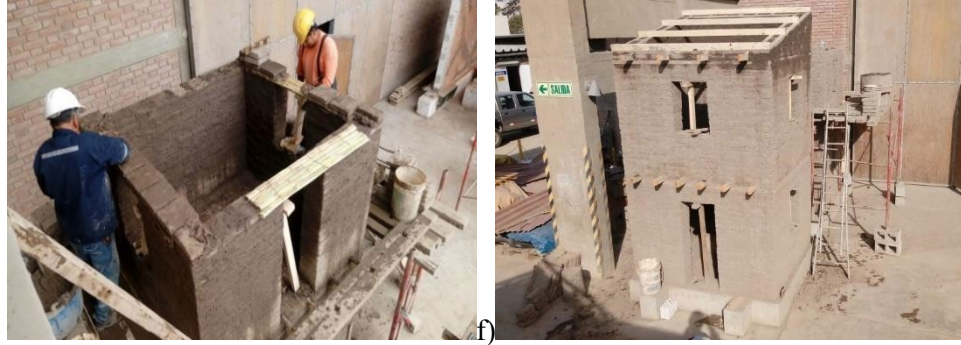
287 Figure 9. Construction process sequence of an unreinforced model. a) b) construction of first level walls;
288 c) and d) installation of the wood crown beam and wood beams; e) lintels of doors and windows (made of
289 cane rods tied with wire), f) finished model (before roof tiles placement).

291 e) f)
 292 Figure 9 (Continuation). Construction process sequence of an unreinforced model. a) b) construction of
 293 first level walls; c) and d) installation of the wood crown beam and wood beams; e) lintels of doors and
 294 windows (made of cane rods tied with wire), f) finished model (before roof tiles placement).
 295

282 Each model was built on a concrete beam that was used as a foundation and as transporting base from the
283 lab yard to the shaking table. Figure 9 shows the construction process of one unreinforced model.

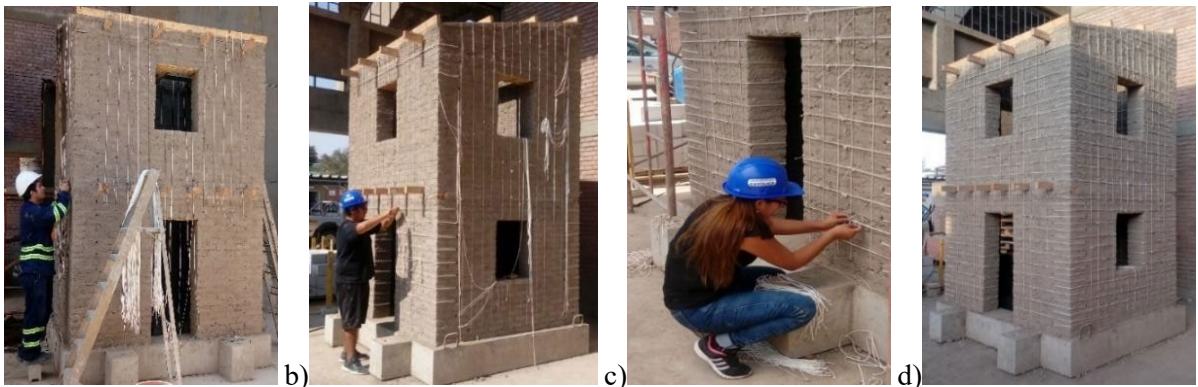
318 a) b) c) d)
319 Figure 11. Sequence for the reinforcement process: a) installation of vertical ropes; b) installation of
320 horizontal ropes; c) joining of inner and outer meshes; d) reinforced adobe model.
321

310 The lower end of the vertical ropes was passed through holes drilled in the mortar layer between the
311 foundation and the walls. Additional holes were drilled to connect the internal and external meshes with
312 pass-through ropes. The first storey vertical ropes were placed first, passed over the wooden floor beams
313 and tied to the second storey ropes. The second storey ropes passed above the wooden roof crown. Then,
314 the horizontal ropes (which were doubled to be more conservative) were placed to form the rope mesh. The
315 inner and outer meshes were joined with pass-through ropes. Figure 11 shows the reinforcement process of
316 one adobe model.

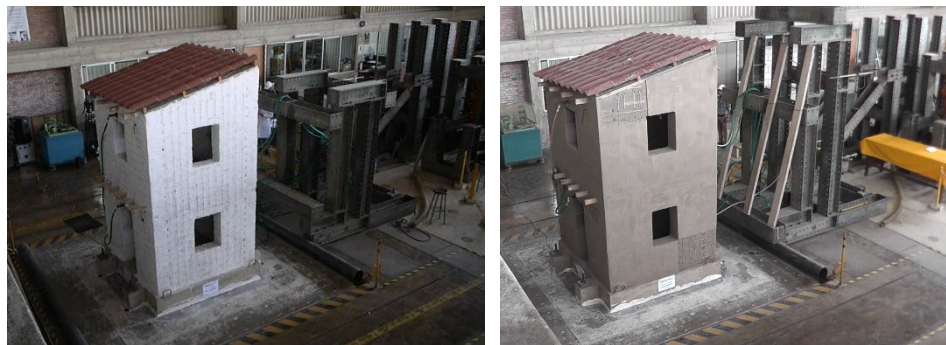
Figure 13. Panoramic view of two adobe models on the shaking table.

368 Each model was placed on the shaking table with the window walls parallel to the platform movement
 369 (Figure 13). Figure 14 summarizes the instrumentation used to record the model response. It consisted of
 370 11 LVDT displacement sensors (D1 to D11), 10 accelerometers (A1 to A10) and 2 load cells (L1 and L2)
 371 placed within selected horizontal ropes. Additionally, the force applied by the actuator (F0) and the table
 372 displacement and acceleration (D0, A0, respectively) were recorded.

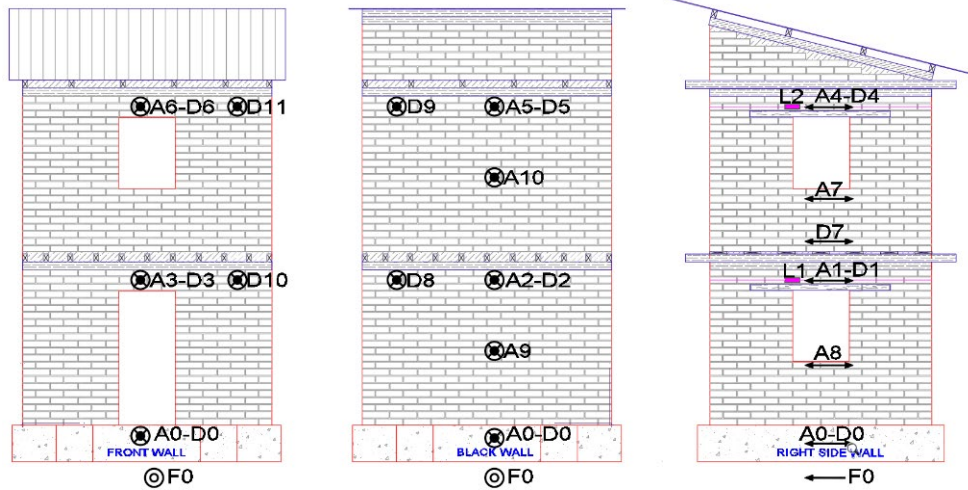
Figure 14. Distribution of LVDTs (D), accelerometers (A) and load cells (L).

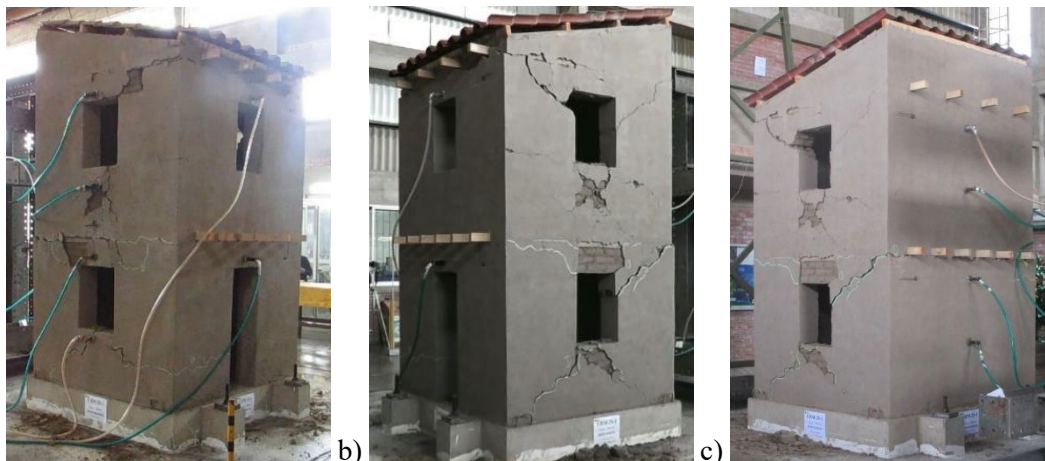
Figure 16. Adobe models after moderate shake: a), b), c) Unreinforced model; d), e) Reinforced model.

409 d) e)
 410 Figure 16. (Continuation) Adobe models after moderate shake: a), b), c) Unreinforced model; d), e)
 411 Reinforced model.
 412

During the moderate seismic motion ($D0_{max} = 30$ mm and $A0_{max} = 1.0g$), the unreinforced model URM-1 suffered visible diagonal cracking on the lateral walls at both levels (Figure 16a,b). Also, horizontal cracks could be observed at the mid-height of the second storey (especially at the front wall) and the base of the sloped roof. At the end of the movement, the first floor back wall suffered a slight rotation due to the out-of-plane actions (Figure 16b,c). At this stage, the building almost lost its structural stability. In the reinforced model SRM-1, some small horizontal cracks appeared at the mid-height of the first floor at the front and back walls, and slightly diagonal cracks at the first-storey walls parallel to the movement (Figure 16d,e).

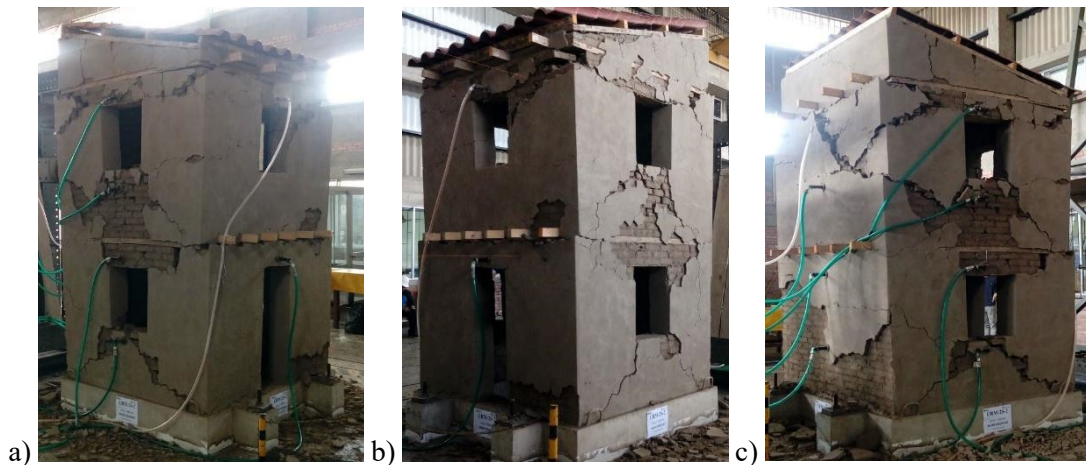
434 Figure 17. Two-storey models after a strong motion: a), b), c) Unreinforced model; d), e) Reinforced
435 model.
436

413 During the strong seismic motion ($D0_{max}= 60$ mm and $A0_{max}= 1.68$ g), the unreinforced model URM-2
 414 model was close to collapse. The front first and second storey walls were separated from the floor beams
 415 due to the out-of-plane actions (Figure 17a,b), and each of them seemed to behave independently of each
 416 other. Thick diagonal cracks were formed on the second storey back wall, across the full wall thickness
 417 (Figure 17c). Diagonal cracks in the lateral walls increased and there was a clear separation between the
 418 walls and the sloped roof. If there were no wooden collar beams on each floor, then the first and second
 419 storey walls could have behaved as a single wall, and the overturning could have occurred with the axis of
 420 rotation placed at the bottom of the first storey wall, as has been reported in some damage studies of other
 421 URM structures (Adhikari and D'Ayala 2020, Varum et al. 2018).

422
 423 In the reinforced model SRM-2 (which had no stucco), horizontal cracks formed near the base of the first-
 424 storey front and back walls, and at the mid-height and top part of the second storey front wall. Also, the
 425 thickness of the diagonal cracks at the first-storey walls (parallel to the movement) increased. With this,
 426 some wall portions were formed; however, the rope mesh reinforcement was able to hold all these wall
 427 parts together. During the second strong shaking, a rocking motion of the wall pieces was observed, but
 428 again the rope mesh avoided the collapse of the structure. The cracks formed in the preliminary motion
 429 opened more, allowing more energy dissipation. Some adobe crushing was also observed below the
 430 windows of the second level (Figure 17d,e).

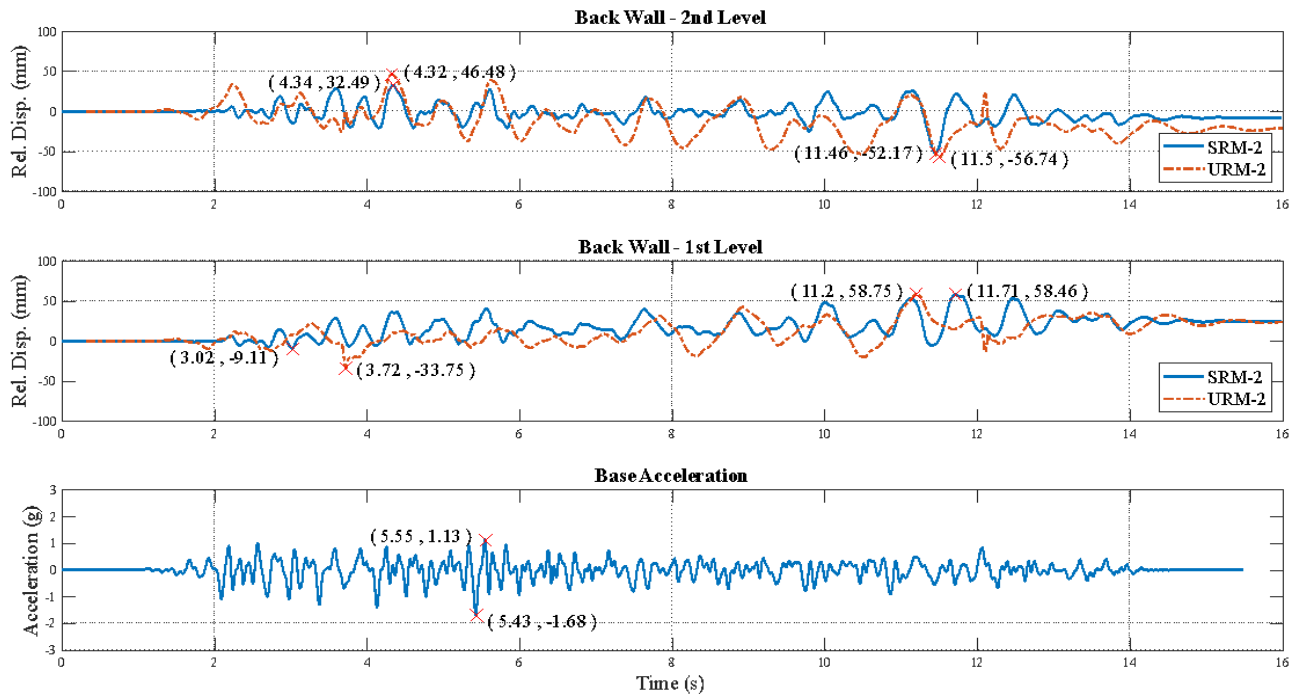
Figure 21. Back wall inter-storey displacements of URM-2 and SRM-2 for strong shaking ($D0_{max}=60$ mm, $A0_{max}=1.68$ g).

509 Figures 20 and 21 show the time history records of relative displacements of the back wall of all models,
510 together with the base acceleration for moderate and strong shaking ($D0_{max} = 30$ mm and $D0_{max} = 60$ mm,
511 respectively). Damage to the unreinforced adobe models is evidenced by the permanent residual
512 deformations, while the string-reinforced adobe models return almost to their original positions.

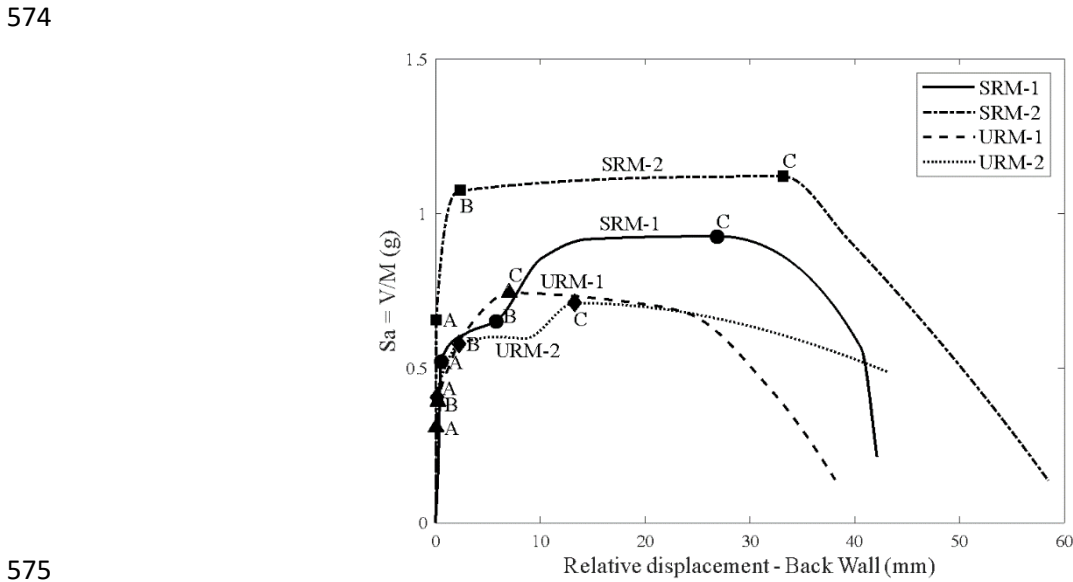
575
 576 Figure 26. Lateral force vs relative displacement envelope – first storey back walls.
 577

568 Finally, Figure 26 shows the first storey lateral force-displacement envelopes for all models (Blondet et al.
 569 2013). For each structure, the base shear was divided by the mass of the whole structure to compute the
 570 pseudo-acceleration S_a . Three points (A, B and C) were then identified in the relative displacement versus
 571 pseudo acceleration graph. Point A corresponds to the displacement at which the elastic behaviour is lost,
 572 point B indicates the beginning of significant nonlinear response and point C indicates the stage of strength
 573 deterioration.

578 The curves in Figure 26 show that the nylon mesh increased the maximum lateral capacity of the SRM-1
 579 and SRM-2 by 50% and 80%, respectively, compared to the unreinforced models. Since the first reinforced
 580 model was subjected to the light, moderate and strong shake, its lateral capacity is less than the second
 581 reinforced model, which was just subjected to a strong shaking. The curve of the SRM-2 in Figure 26 was
 582 computed considering only the first strong shake. The difference in lateral capacity in the reinforced models
