1 Building constructions characteristics and mechanical properties of confined masonry walls
2 in San Miguel (Puno-Peru)

4 Tarque Nicola ^{(1)*}, Pancca-Calsin Erika ⁽²⁾

5 ¹ Pontificia Universidad Católica del Perú. GERDIS Research Group, Civil Engineering Division.

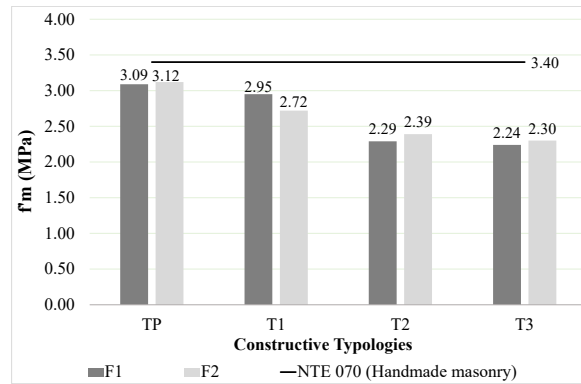
405 **Figure 12. Characteristic strength to axial compression in TP, T1, T2 and T3 piles.**

397 Figure 12 shows a summary of the 24 results obtained from the axial compressive strength tests on
398 masonry piles. As can be seen, the f_m values obtained for TP did not reach the recommended value
399 by NTE 070 for handmade bricks (3.40 MPa), even though an adequate mortar was used in this

400 typology. It can be pointed out that this typology is the closest to the value recommended by the
 401 Peruvian standard. The f_m results obtained for the other typologies (T1, T2 and T3) are lower than
 402 the minimum recommended value. Therefore, the poor construction quality of the masonry walls in
 403 San Miguel is demonstrated.

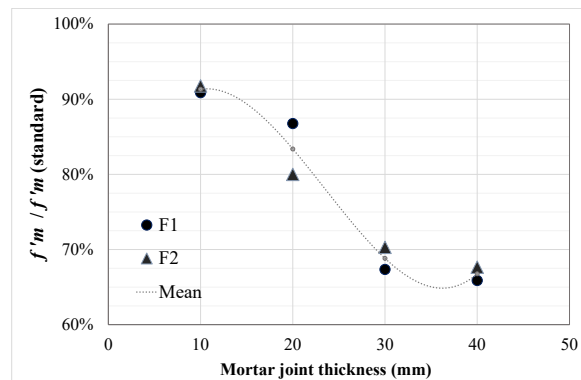
415 **Figure 13. Variation of f_m according to TP, T1, T2 and T3 mortar joint thickness.**

407 According to values obtained for typologies T1, T2 and T3, it can be deduced that the characteristic
 408 strength to axial compression in piles is inversely proportional to the joint mortar thickness; that is,
 409 as the mortar joint thickness increases, the axial compression strength decreases. As shown in Figure
 410 13, the f_m value of TP (thickness $e= 10\text{ mm}$ and mortar 1:4) is 90% of the standard f_m ; of T1 ($e= 20$
 411 mm), between 80 and 88% of the standard; of T2 ($e= 30\text{ mm}$), between 67 and 70% of the standard;
 412 and T3 ($e= 40\text{ mm}$), 68% of the minimum specified value in the standard. It is also indicated that the
 413 mortar used in TP had a compressive strength of 14.4 MPa , and in the others of 8.2 MPa .

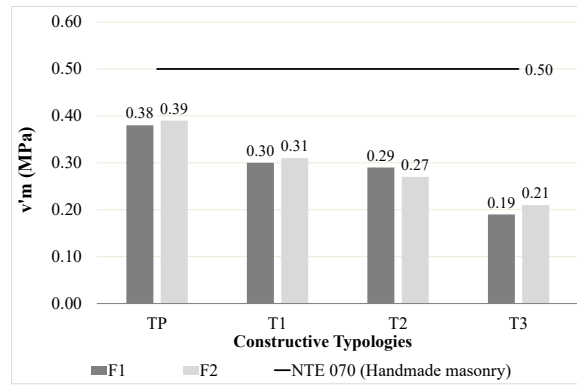
442 **Figure 14. Diagonal tensile (shear) strength characteristic for TP, T1, T2 and T3 walls**

432 Figure 14 shows the results obtained from the diagonal tensile strength tests on masonry walls
433 following the ASTM E-519 (2021) and NTP 399.621 (2004), no deformation gauges were used.
434 Even though the TP walls were built with a good quality mortar and respecting the thickness of the
435 joints, their $v'm$ value did not reach the minimum value recommended by NTE 070 (2006) for
436 handmade bricks ($0.50 MPa$). The diagonal tensile (shear) strength values of the other typologies are
437 well below the recommended minimum. This situation is of concern since $v'm$ is a direct value to
438 evaluate the seismic capacity of confined masonry housing. It is essential to mention that the $v'm$ for
439 industrial bricks is $0.80 MPa$ according to the standard. In case to use RILEM TC 76-LUM (1994)
440 standard, the computed tensile strengths will be less than the ones reported in Figure 14.

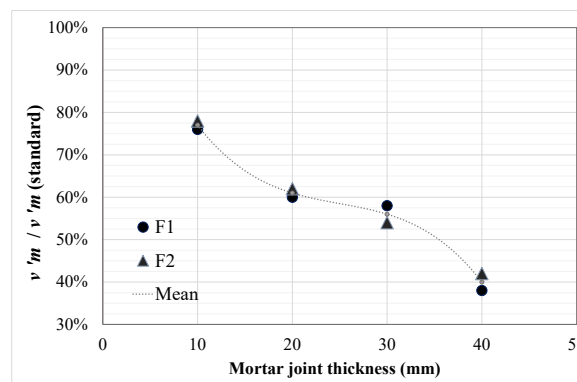
452 **Figure 15. Variation of $v'm$ according to TP, T1, T2 and T3 mortar joint thickness.**

445 Similar to piles, it can be deduced that the characteristic strength to diagonal shear in walls is
 446 inversely proportional to the thickness of the mortar joint; that is, as the thickness of the joint mortar
 447 increases, the diagonal shear strength decreases. Figure 15 shows that the $v'm$ value of TP ($e= 10$
 448 mm) is around 77% of the $v'm$ of the standard; of T1 ($e= 20 mm$) 60% of the standard; of T2 ($e= 30$
 449 mm) between 54 and 58% of the standard; and T3 ($e= 40 mm$), between 38 and 42% of the minimum
 450 value specified in the standard.
