# SEISMIC STRENGTH OF ADOBE MASONRY\*

Julio Vargas Neumann  
Juan Bariola Bernales  
Marcial Blondet  
Povindar K. Mehta

PUBLICATION DI-84-01  
APRIL 1984

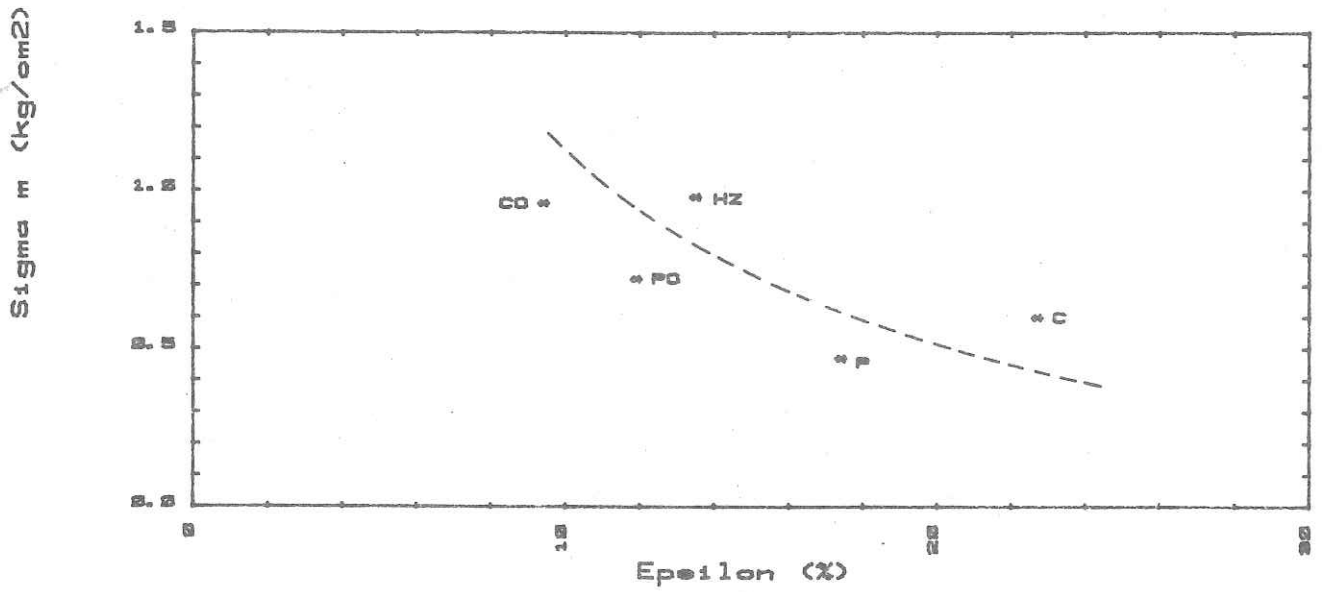
FIG.5 DIAGONAL COMPRESSION STRENGTH vs VOLUMETRIC SHRINKAGE OF BRICK

One of the most important conclusions drawn from the analysis of the test results is that the strength of adobe masonry greatly depends on the degree of microcracking of the soil mortar due to drying shrinkage. Fig. 5 shows a clear correlation between the volumetric drying shrinkage of adobe bricks – which also indicates the capacity for drying shrinkage of the mortar – and the strength of the masonry. In order to obtain a strong masonry it is therefore indispensable not only to have a material with high dry strength, but also to guarantee the integrity of the brick-mortar ensemble by eliminating or reducing microcracking of the soil mortar.

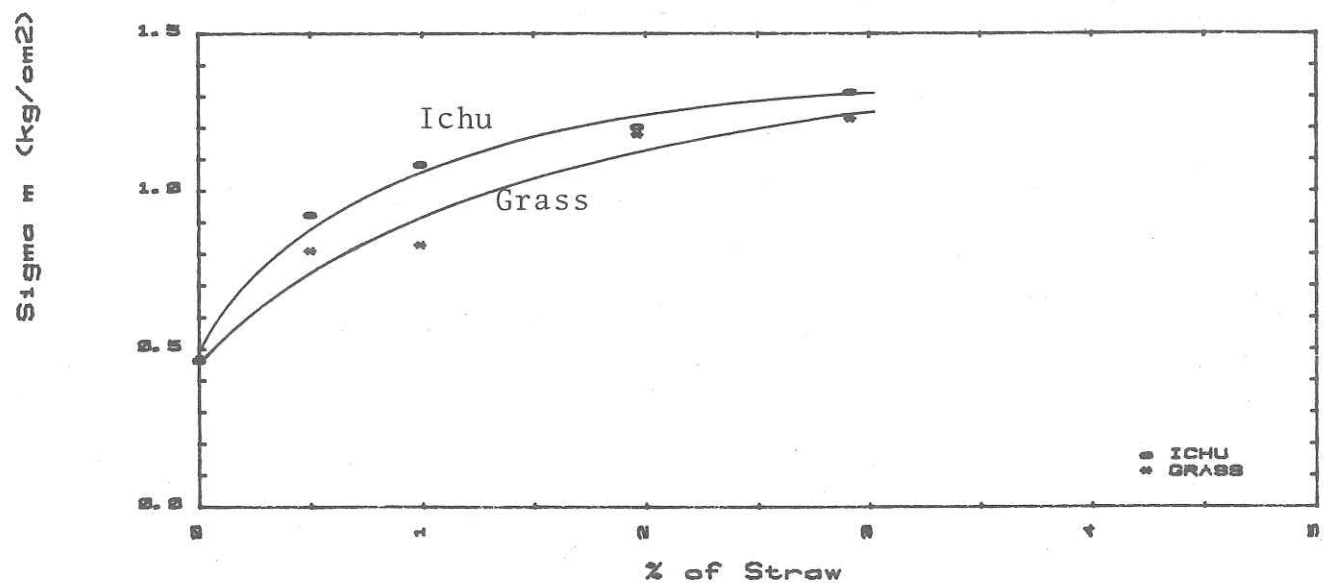
FIG.12 EFFECT OF ADDITION OF STRAW TO PUC SOIL

Addition of straw was found to be even more efficient than addition of coarse sand in improving the strength of adobe masonry (Compare Figs. 10 and 12). Practically the same results were obtained with both types of straw. The increase in strength can be explained by the "sewing" action of the brick-mortar interface produced by the straw fibers in the mortar. This effect helps to improve the integration, and thus the strength of adobe masonry. The compressive strength of the brick was not found to decrease, as in the case of addition of coarse sand. However, the water demand of the mortar to reach an adequate workability increased with the addition of straw. Therefore, addition of very large amounts of straw is not convenient. The optimum amount to be added to a given soil is then controlled by the workability of the soil-straw-water mixture used to make the adobes and mortar.

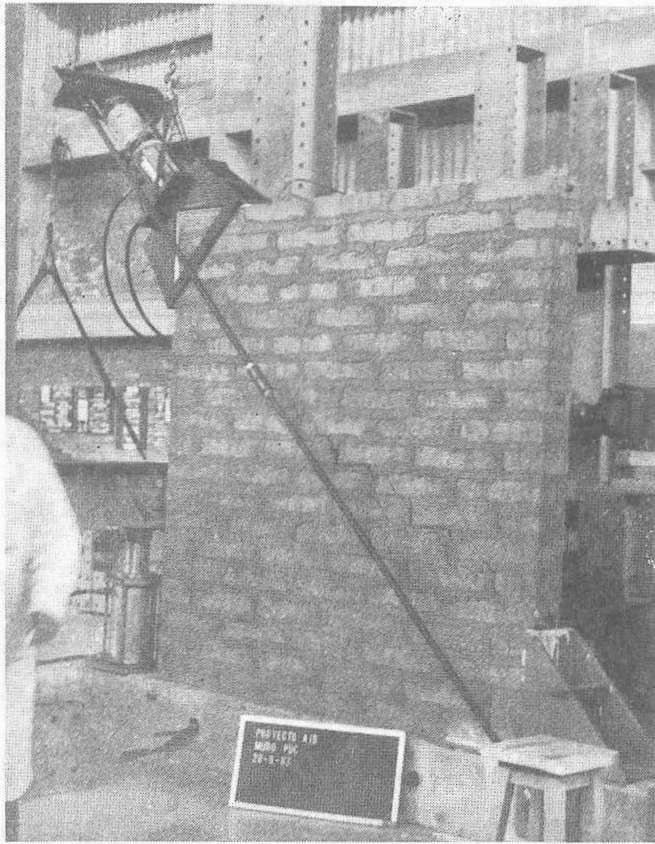
FIG.13 SHEAR TESTS ON FULL SCALE WALLS

Full-scale shear tests on adobe walls were performed to corroborate the observed beneficial effects of addition of coarse sand or straw to the natural soil. Fig. 13 shows the test set-up. The improvement of strength obtained was in this case of the order of 100<sup>o</sup>/o, with respect to walls made with natural soil (see Fig. 14). This implied an increase in strength of the order of 400<sup>o</sup>/o with respect to traditional adobe masonry.

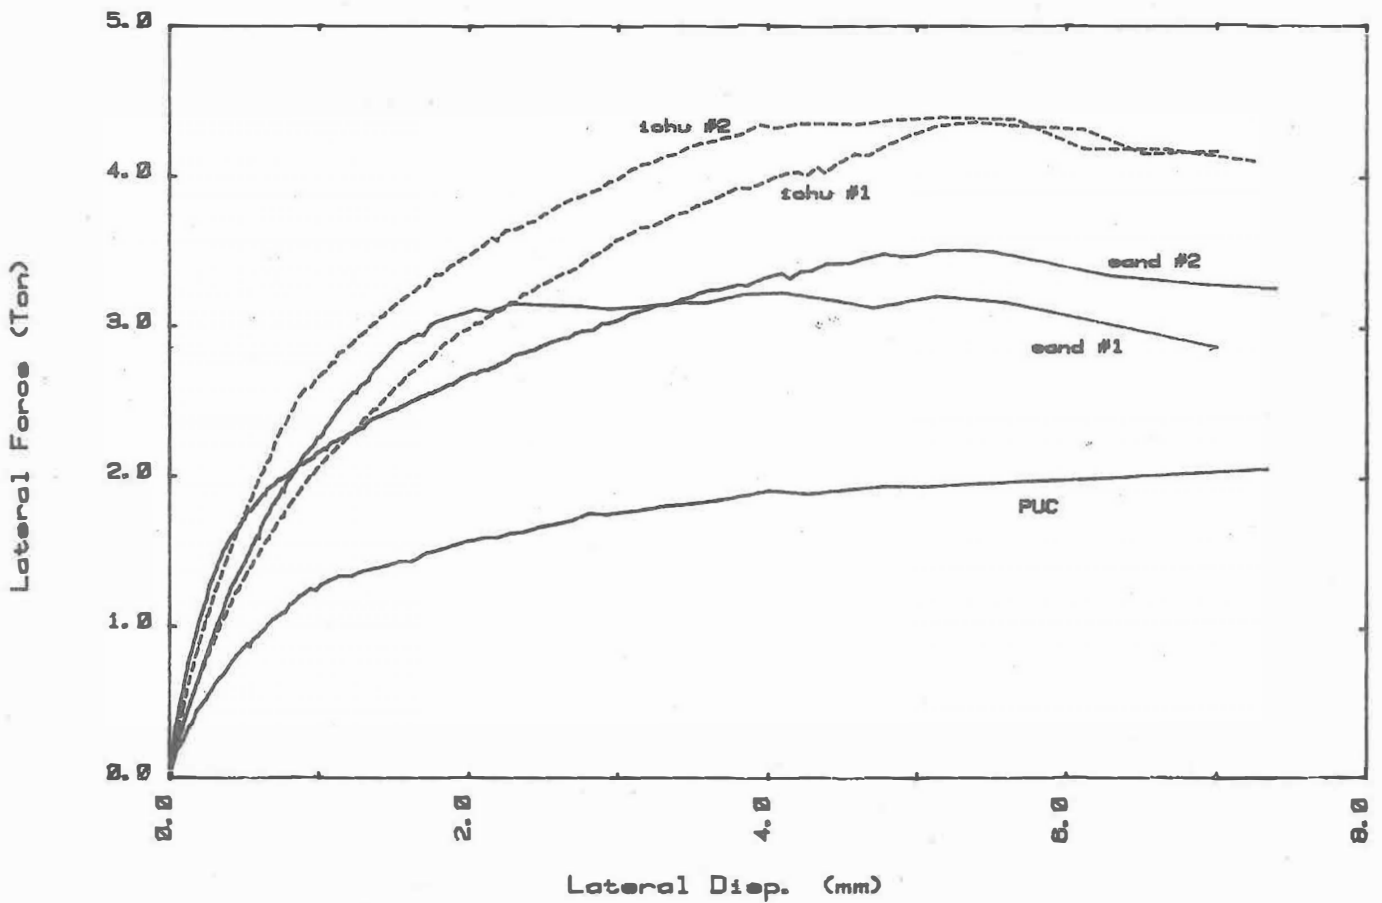
FIG.14 FULL SCALE WALL TEST RESULTS
